**CONTINUING ELIGIBILITY INSPECTION (CEI) REPORT FOR
FLOOD CONTROL WORKS (NON-FEDERAL)**
Honolulu Engineer District
CEPOH-EC-T

1. Project Name: **Moanalua Stream Flood Control Project**
2. Date of Inspection: December 10, 2003 (Wednesday)
2a. Date of Storm: December 7, 2003 (Sunday Night)
2b. Mapunapuna Photos: December 8, 2003 (Monday Morning)

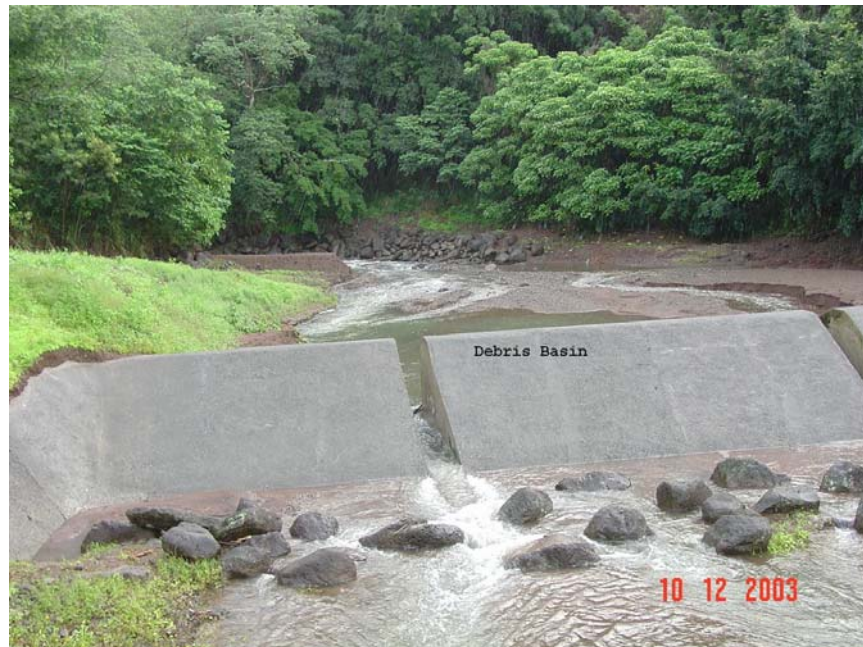
a. Debris Basin during inspection.

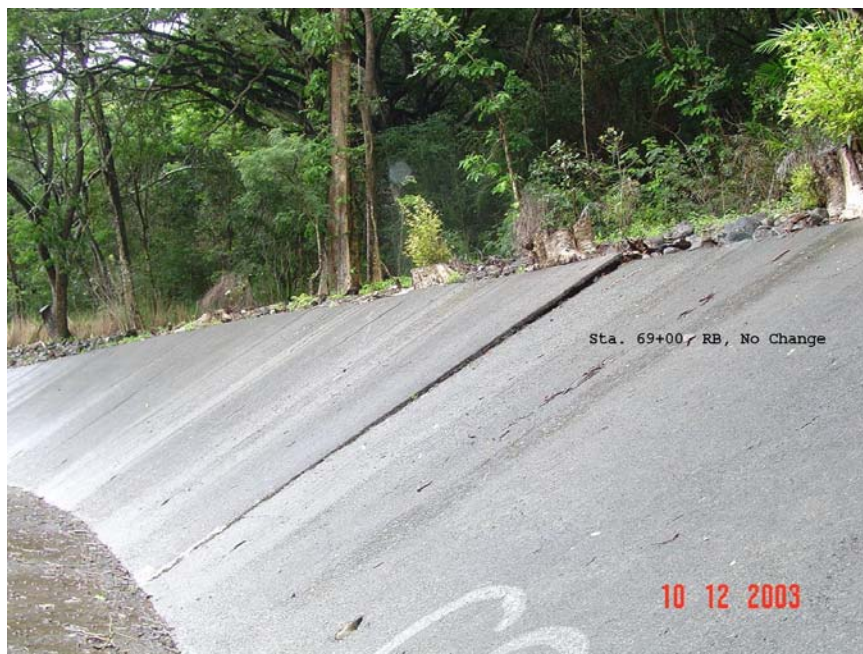
b. Sta. 69+00, RB, repair concrete sideslope.

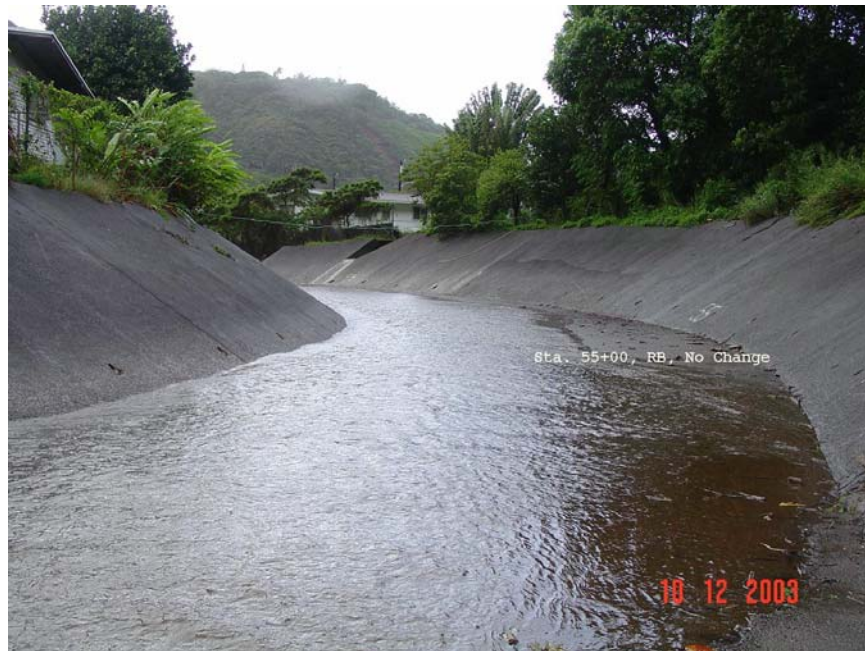
c. Sta. 55+00, No Change.

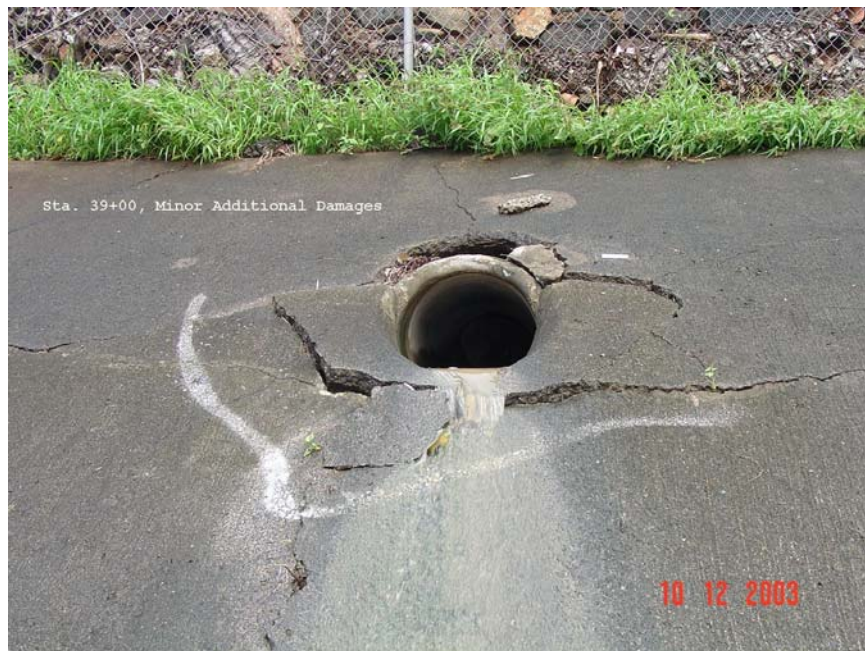
d. Sta. 39+00, Additional damage.

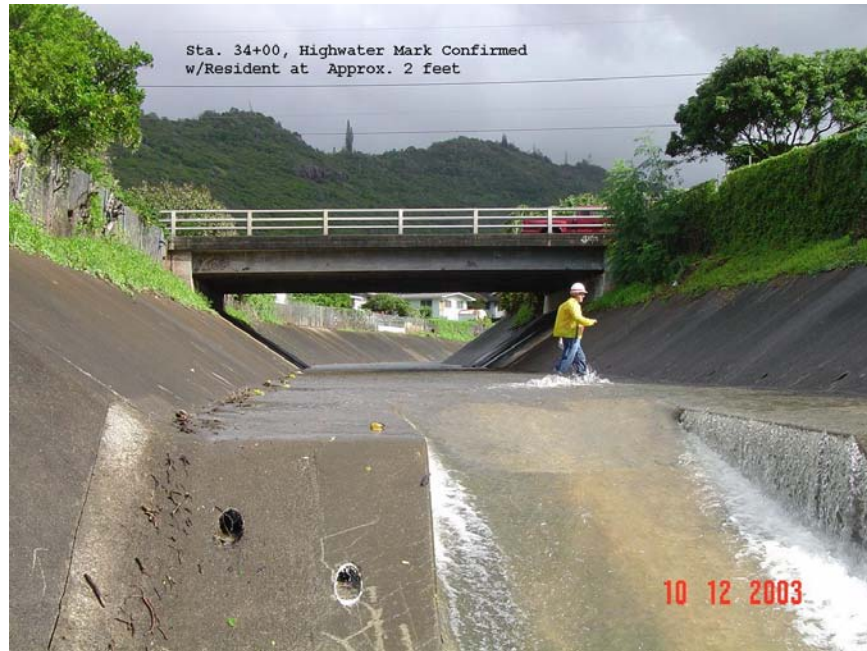
There has been little additional damage as a direct result of this storm event. High-water marks indicated the water was less than 2 feet in the channel invert for the lined portion of the stream.

e. Sta. 34+00, LB, High-water mark approx. 2 feet during event.

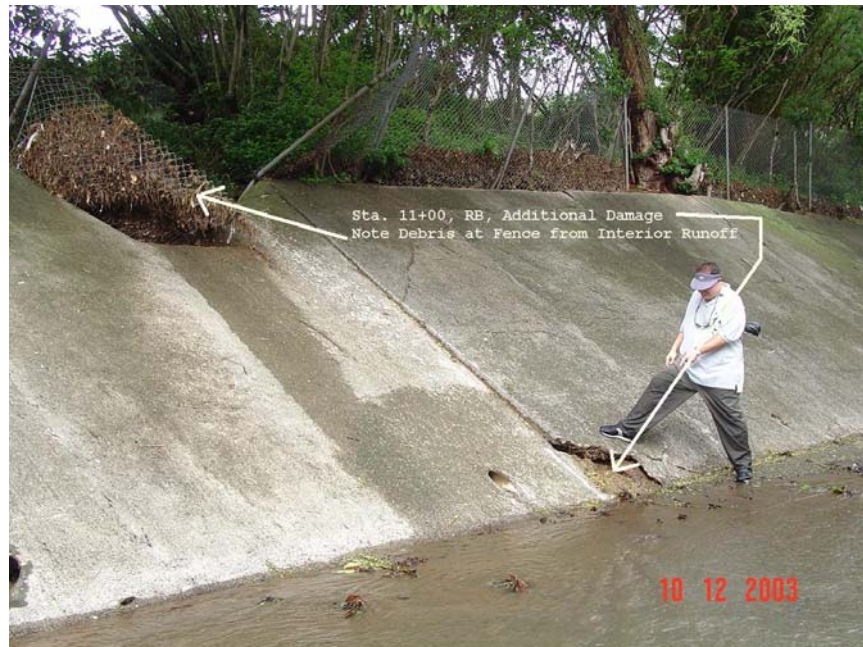
g. Sta. 11+00, RB, additional damage to concrete sideslope.

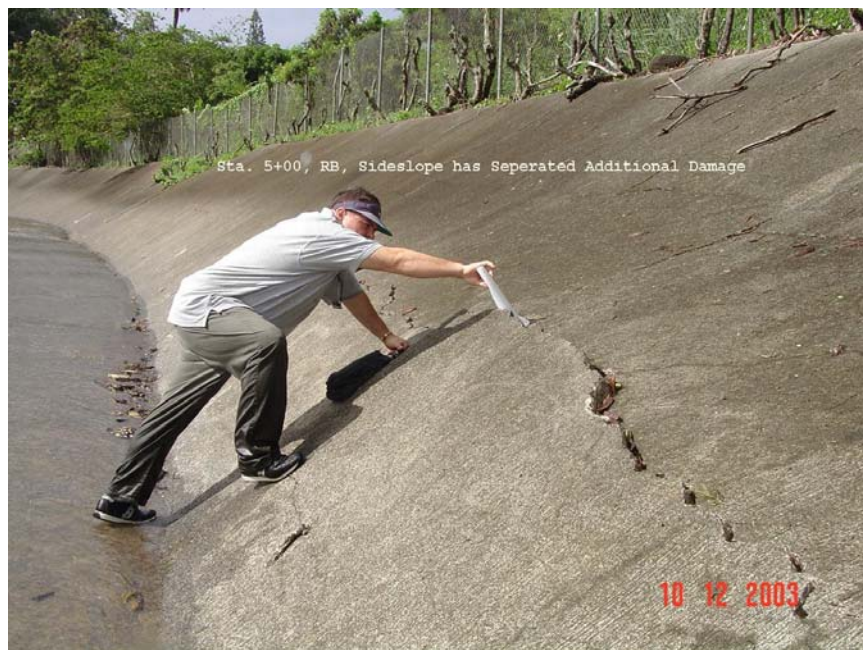
h. Sta. 5+00, RB, additional damage (separation) concrete sideslope.

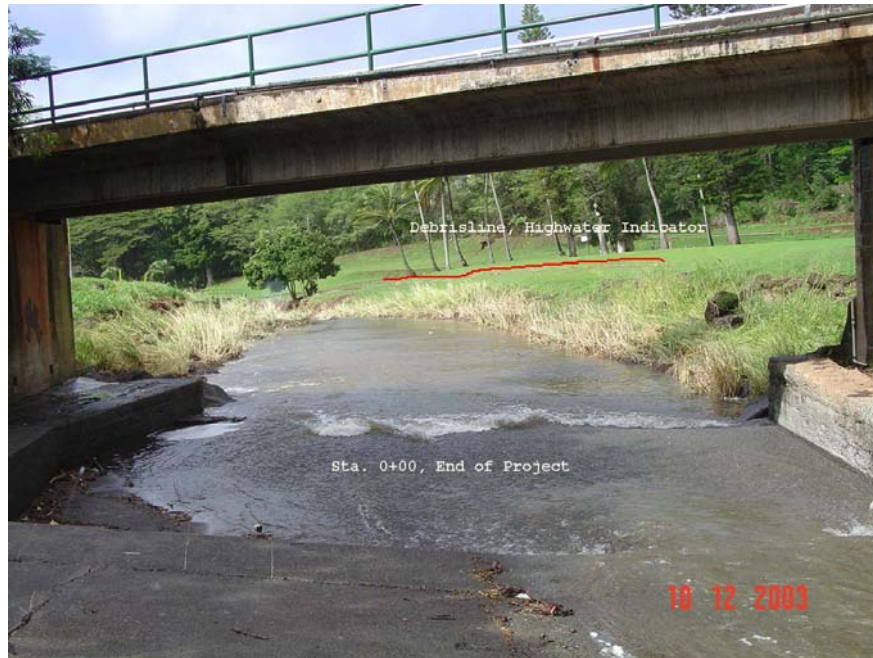
i. Sta. 0+00, Lower limit of Project.

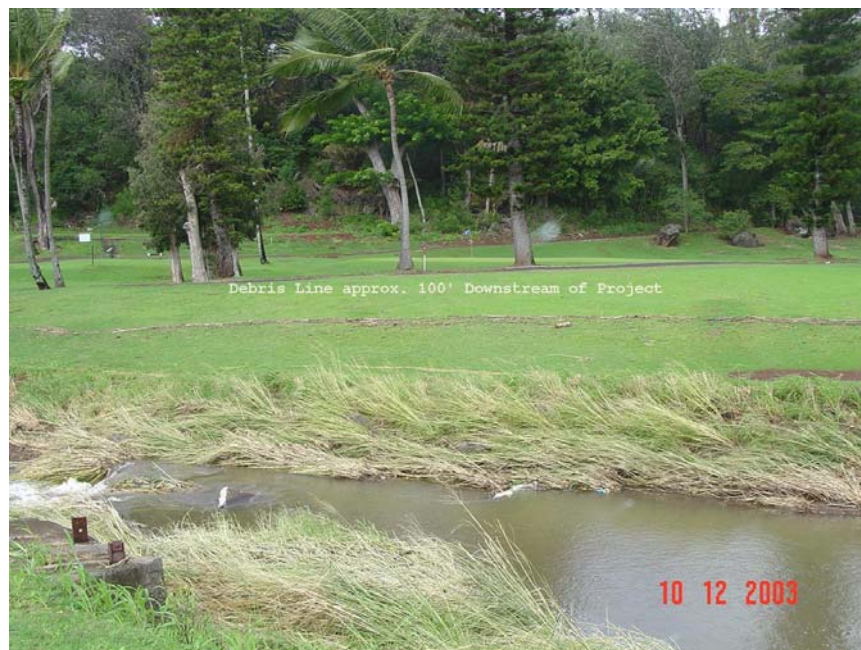
j. Debris Line approx. 100' downstream of project, RB.

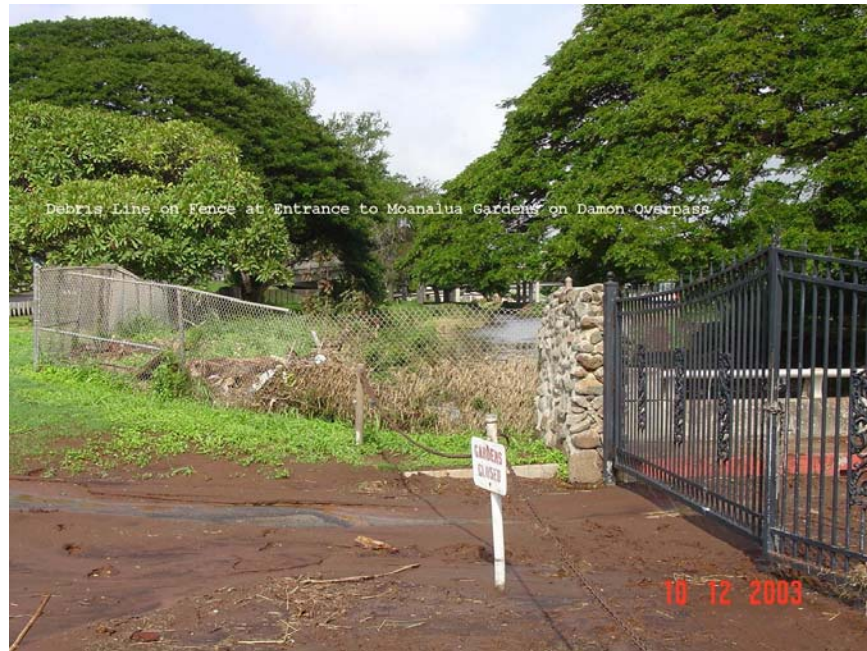
k. High Water Marks on fence at entrance to Moanalua Garden.

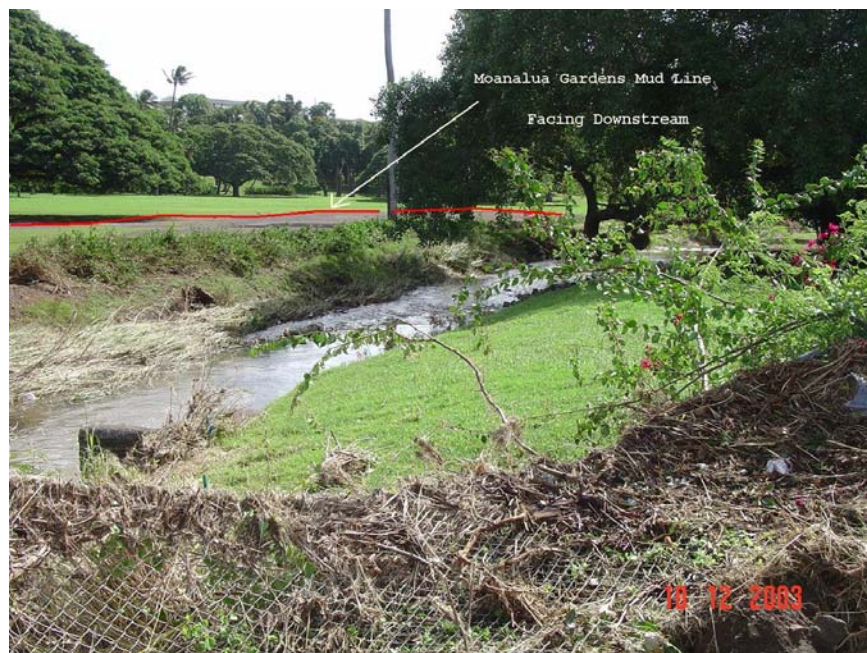
l. Overview of Moanalua Garden , Note Mud line.

The overall condition of the channel is **POOR**. Worsening of existing conditions on the project occurred only at a few locations. Flooding at the Moanalua Gardens was likely caused by existing stream invert size and flooding at the Mapunapuna Industrial Area was likely caused by debris and vegetation being stuck at the Kikowaena St. Bridge.

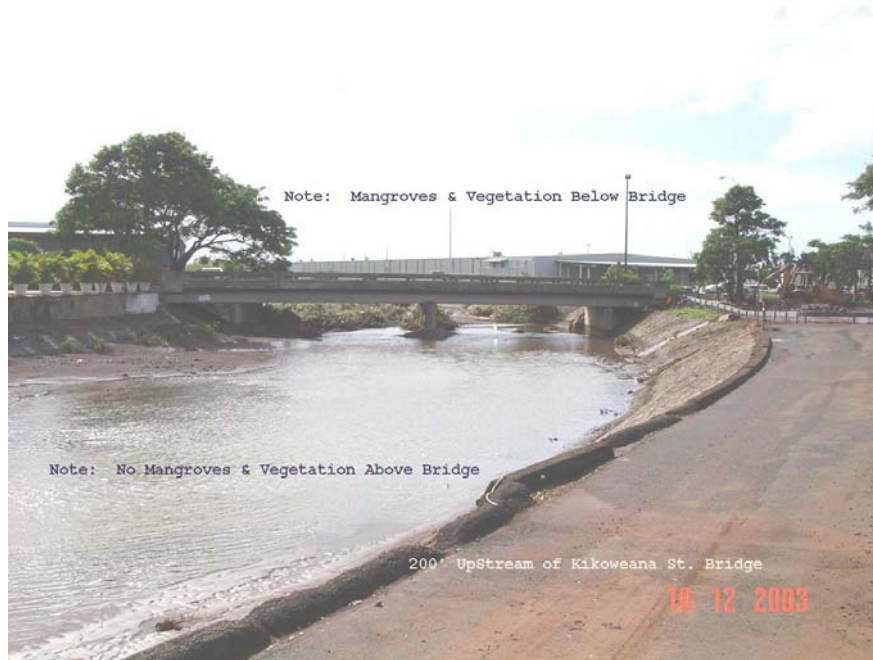
m. Overview of Moanalua Stream above Kikowaena St. Bridge.
